Giving Guildford's gateway a makeover

The distinctive Farnham Road car park in Guildford has been given a thorough overhaul by Concrete Repairs using Sika systems

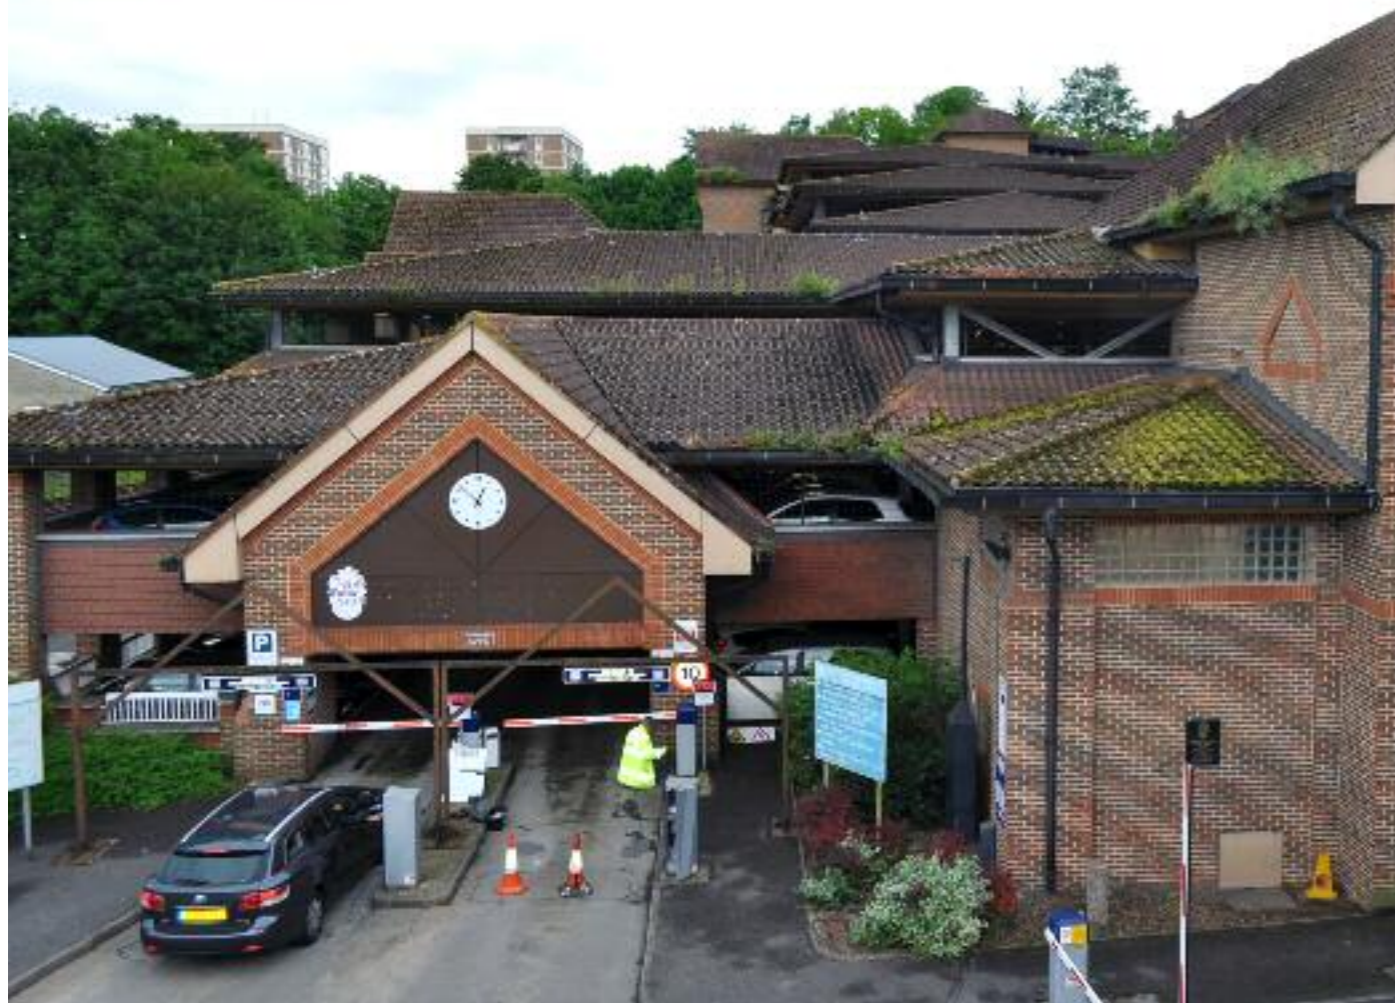
Farnham Road before the refit, complete with blocked gutters

appointed to oversee works repair and rehabilitate the car park, as well as improve its aesthetics. Following a tender process in August 2013, specialist contractor Concrete Repairs Ltd (CRL) was appointed and commenced work on site with a programme period of 16 weeks. The scope of the works predominantly comprised the repair and resurfacing of the car park, including barrier refurbishment and remote gutter

cleaning and maintenance. Auxiliary works included: isolated concrete repairs to both slabs and soffits; the removal of ridging to the ramps at the tops of nibs; the preparation of the existing concrete decks prior the application of the Sika decking systems; removal of all paint to skirtings and kerbs; removal of all speed bumps; and the installation of pigeon protection measures. CRL opted to use the Sika car park decking system as its

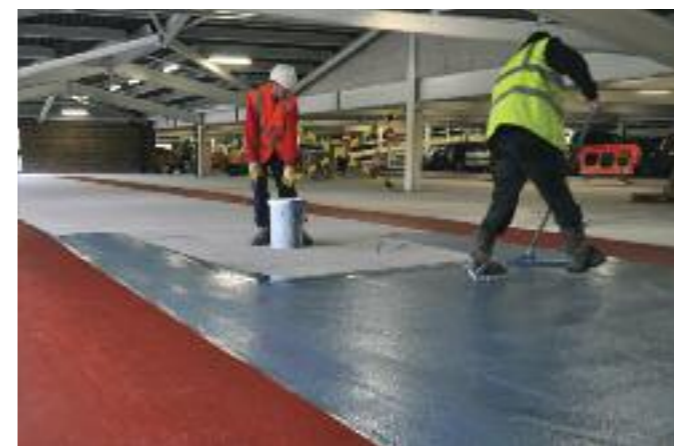
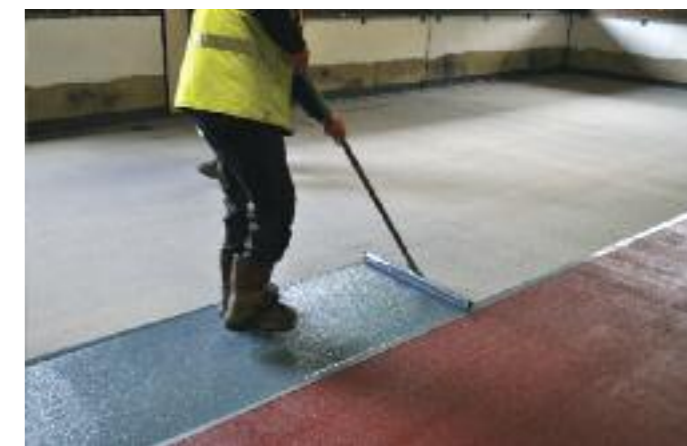
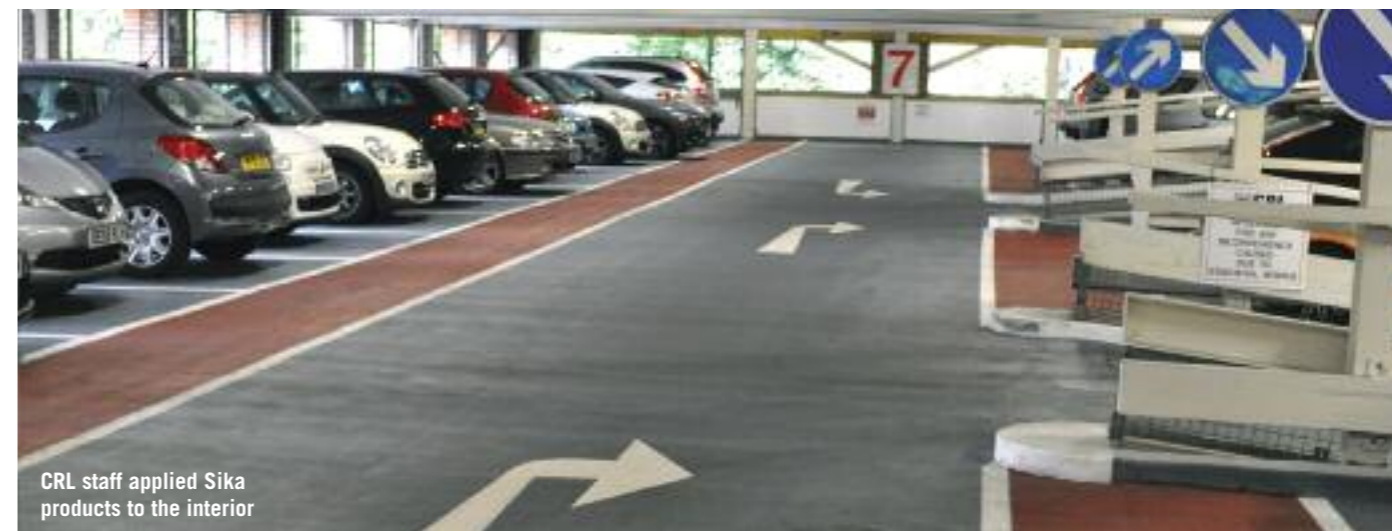
CRL staff applied Sika products to the interior

preferred option for the ramps, turning circles and the remainder of the car park decks. The Sika system was selected on account of its durability, cost effectiveness and fast curing properties that allow critical areas to be trafficked after four hours. This enabled circulation to be maintained in the car park, which remained operational throughout the works. Sika's Ferrogard 903 migrating corrosion inhibitor was specified for application to all the deck surfaces to reduce the corrosion rate where corrosion had already begun. The 903 system was also used to protect reinforcement in areas where corrosion had not yet started.
